# AS4110 can't be detected in network

Release Date:7/15/2015

GV-AS210 / 2110 Kit: Firmware V1.23

GV-AS410 / 4110 / 810 / 8110 IP Control Panel and Kit: Firmware V1.23

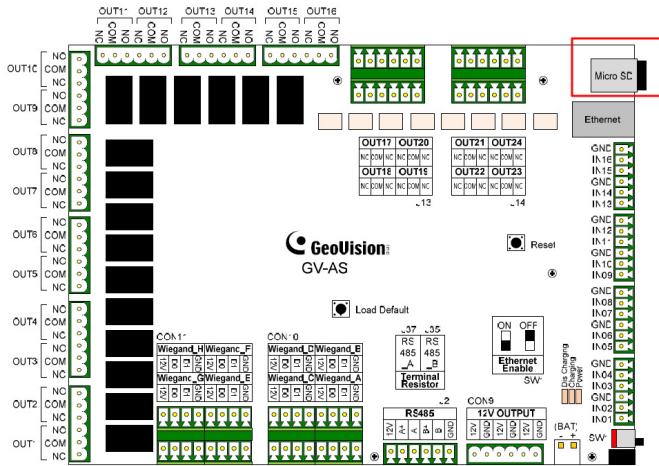
SD card might need to repair for some reason (power failure, firmware upgrade fail..), controller will try to repair it when power on, but controller seems stuck initial process to check SD card, it cause network connection not stable

- power off controller
  - remove sd card from controller's board SD card slot
-
