Why is part of the 5 MP fisheye view missing?

Article ID: GV12-11-29-t

5 MP GeoVision Fisheye IP Camera

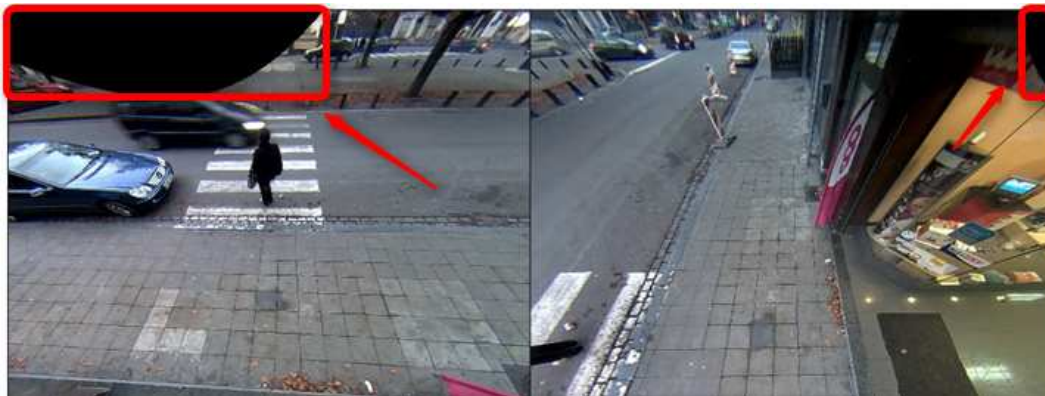
Why is part of the 5 MP fisheye camera view missing?

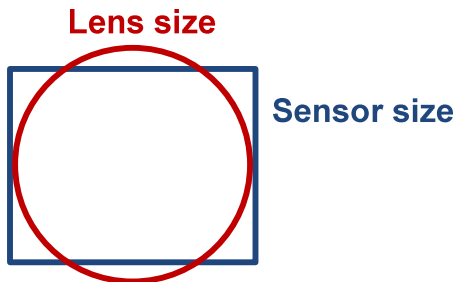
This is a hardware specification of the 5 MP fisheye cameras. The circular lens of the fisheye camera is slightly larger than the size of the camera sensor. The missing areas of the fisheye view are where the lens size exceeds the sensor size.

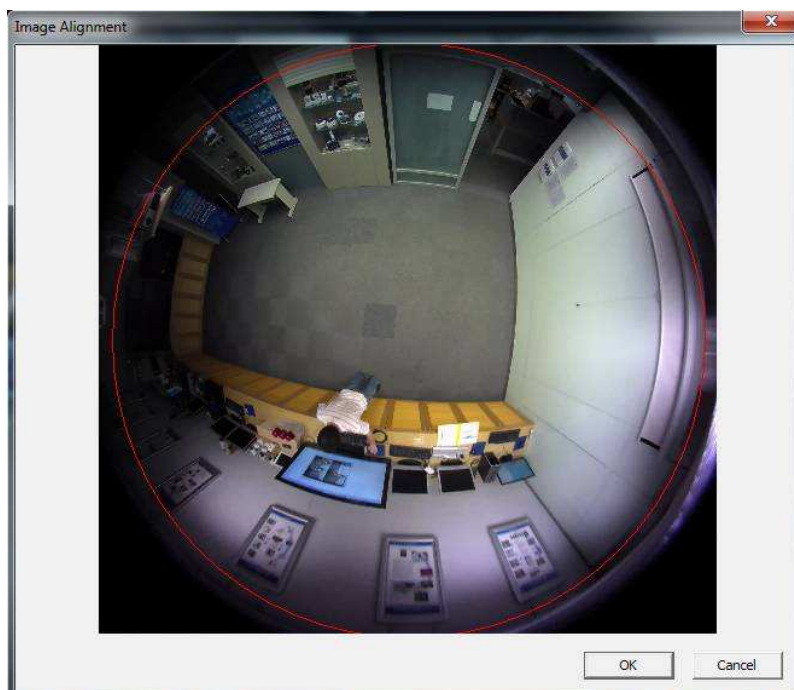
1. Login to the Web interface of the fisheye camera, right-click the live view and select **Geo Fisheye**.
2. Right-click the live view again, select **Fisheye Option** and select **Image Alignment**.
3. Drag the red circle to adjust the image alignment.

You can eliminate the dark areas of the camera view by reducing the size of the Image Alignment circle, but field of view will also be reduced. To adjust the image alignment, follow the steps below:
